NBS TECHNICAL NOTE 807

Building Performance in the 1972 Managua Earthquake

Following the Managua, Nicaragua, earthquake of December 23, 1972, a team of engineers representing the U.S. Department of Commerce's National Bureau of Standards (NBS) and the National Academy of Engineering (NAE) performed field investigations in Managua, Nicaragua, from December 26, 1972, to January 4, 1973. The objectives were to assist the Nicaraguan government in surveying major buildings to determine whether each was suitable for emergency use, repairable, or appropriate for clearance. The team also viewed the patterns of successful performance and damage to identify needs for improvements in building practices for mitigation of earthquake hazards and opportunities for more detailed investigations which could provide information for future improvements in practices.

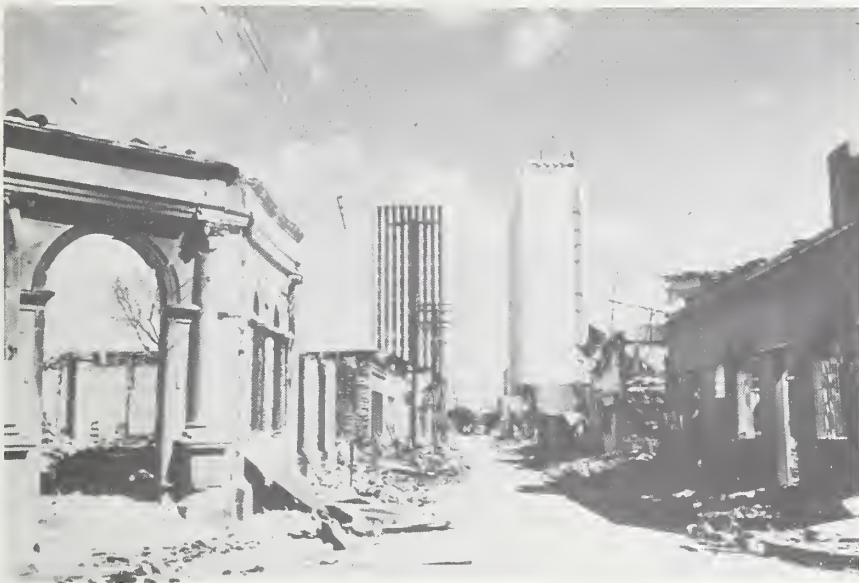
This report is limited to the main high-rise building of the bank, figures 52-1 and 52-2. The structure appears to have no critical damage in its main load carrying elements. However, it is recommended that the following actions be taken before it is repaired and occupied.

Figure 52-1 Banco de America (left) and Banco Central (right) survived amid collapsed low buildings of taquezal construction.

1. Check connections of the columns and beams on the "skin", especially at the fourth floor.
2. Check cracking of the shear walls below the seventh floor.
3. Check connections of the floor beams with the columns at levels above the fourth story, especially on the west end of the structure.
4. Analyze the structure for a base motion input at least 50 percent more intense than the one measured at the Esso Refinery on December 23, 1972 or according to the results of a complete site study.

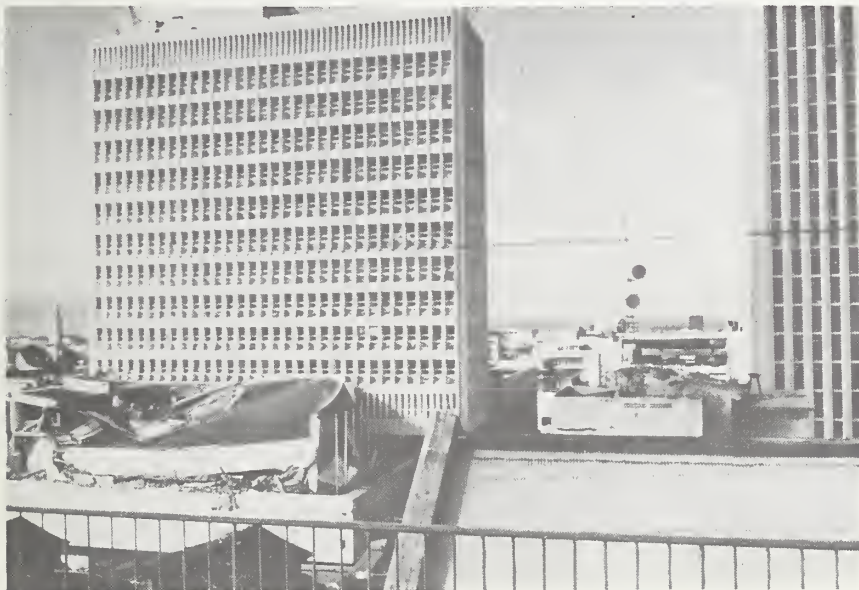
Figure 52-2 Collapsed auditorium and cracked infill walls on framed tube tower.

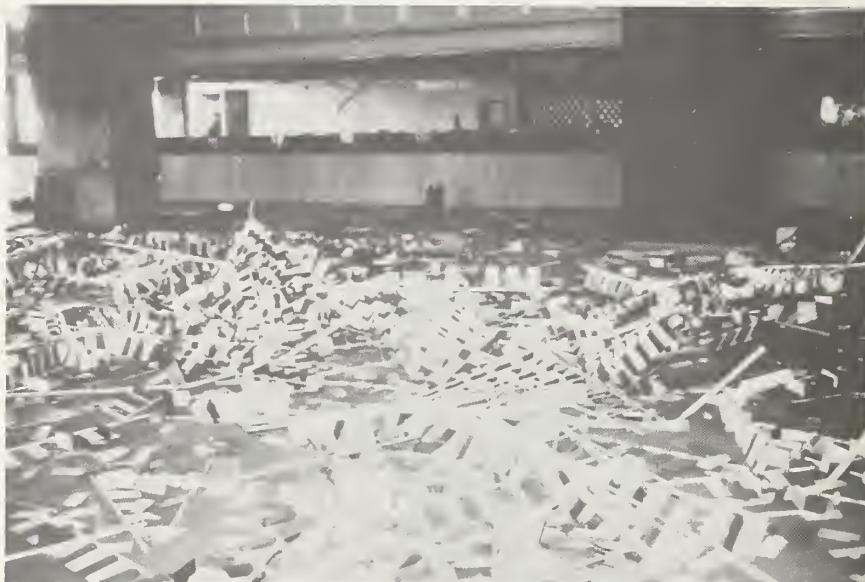
The frame was sufficiently flexible to allow extensive non-structural interior damage, figures 52-3 and 52-4.

Figure 52-4 Suspended ceiling fallen to floor of main lobby, Banco Central.

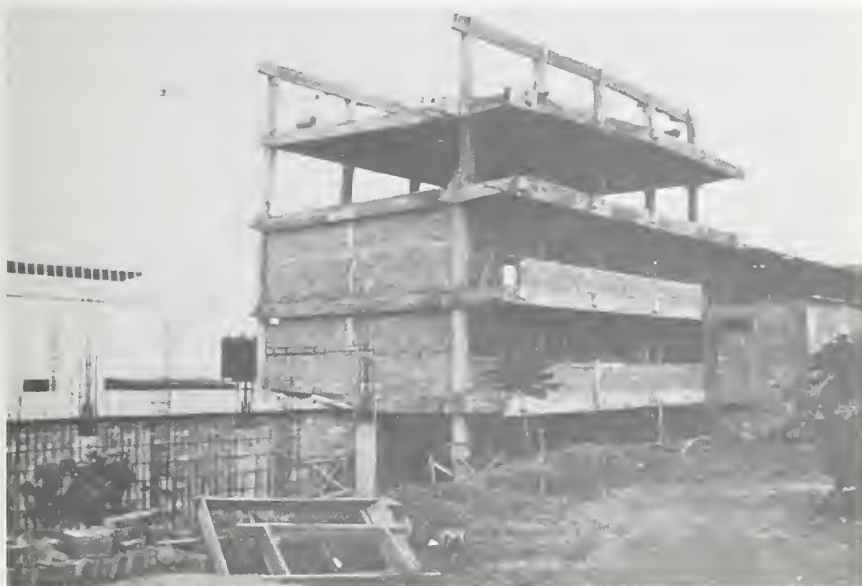
A one story building with a shell roof exhibits failures of the supporting columns, figure 53-3. A multistory reinforced concrete frame building, under construction and partially infilled shows frame failures in unfilled stories, figure 53-4.

Figure 53-4 Frame failures in building under construction, Seminario Catolico.

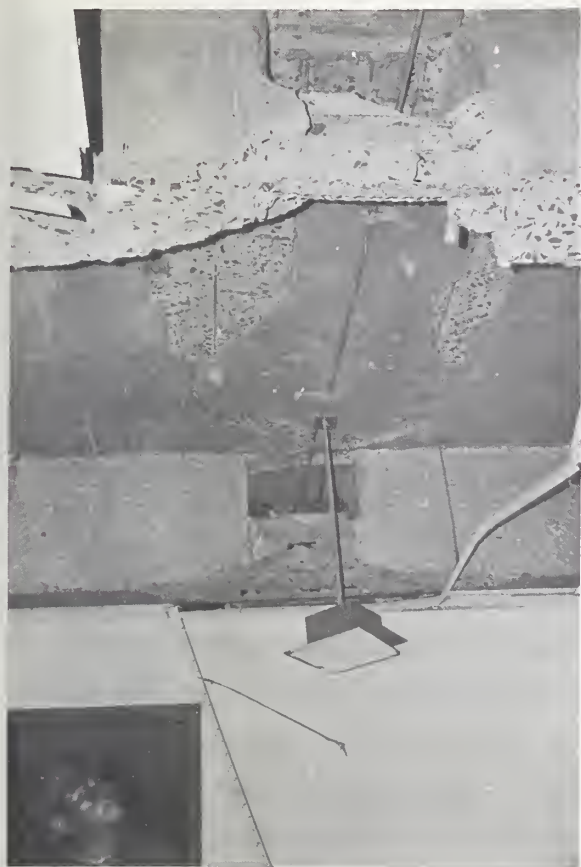
Figure 54-1 Failures of beams connecting shear wall towers, Banco de America.

1. Analyze the structure (in the form it is to be completed for a base motion input at least 50 percent more intense than the one measured at the Esso Refinery on December 23, 1972, or according to the results of a complete site study).
2. Check shear walls for alignment in the vertical direction.
3. Check connections between slab and edge of columns and shear walls at levels above the seventh floor.
4. Check slab between shear walls at levels above the 12th floor.

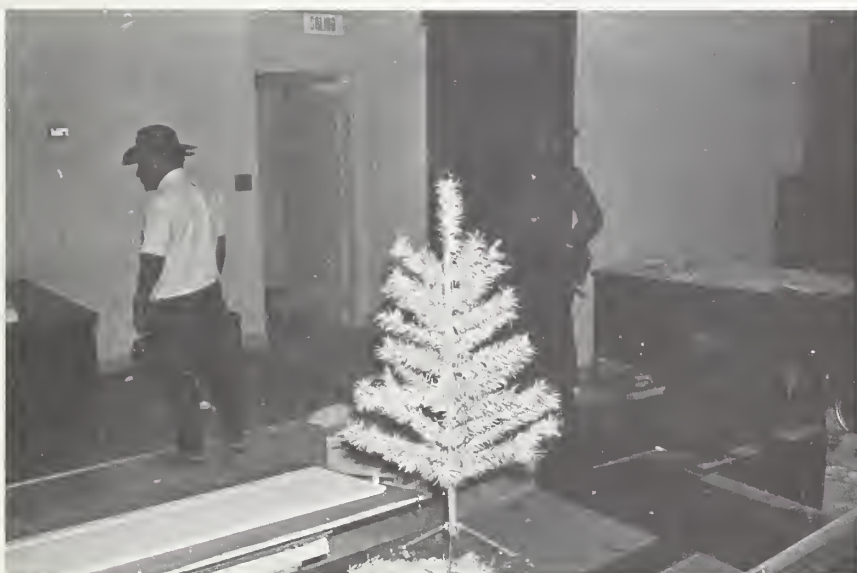
The good condition of the interior shows the advantages of the drift restraint provided by shear walls, figure 54-2.

Figure 54-2 Good condition of interior due to control of drift, Banco de America.

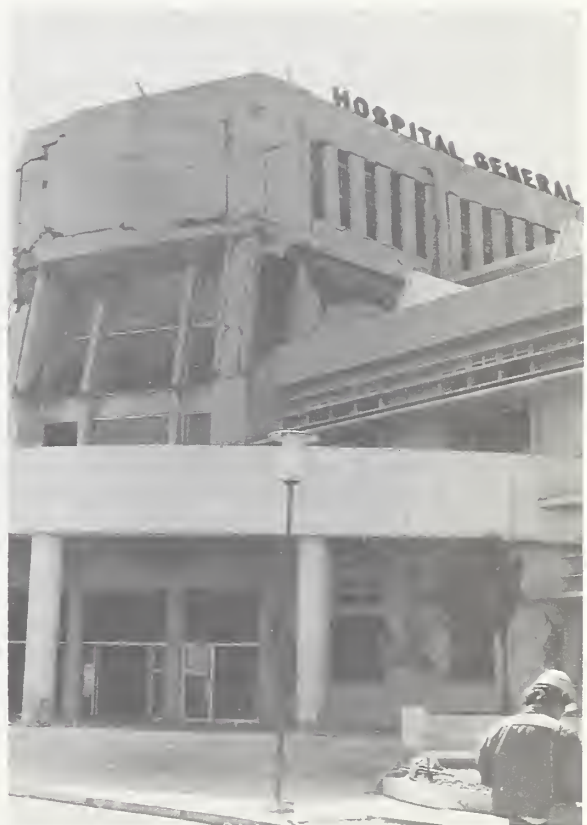
This building with four, three-story wings on a semi-basement and a four-story central portion was completed in 1962, figure 55-1. It appears to be a reinforced concrete frame without shear walls. Damage at the north front of the building is substantial, figures 55-2, 55-3, and 55-4. Exterior columns in the walls of the wings are extensively broken by cracks originating in the infill walls which caused concentration of deformations in the columns, figure 55-5. Interior columns in the wings show little distress, figure 55-6. The four story building at the intersection of the wings shows severe damage to columns and partial collapse at the south of the third floor, figure 55-7. The damaged columns appear to be reinforced with undeformed steel which is very lightly tied.

Figure 55-2 Damage at north facade of Hospita General El Retiro

Major repairs would be required to make the structure safe for future occupancy. Changes in the structural system, such as additions of shear walls, would appear to be necessary to avoid similar damages in future earthquakes.

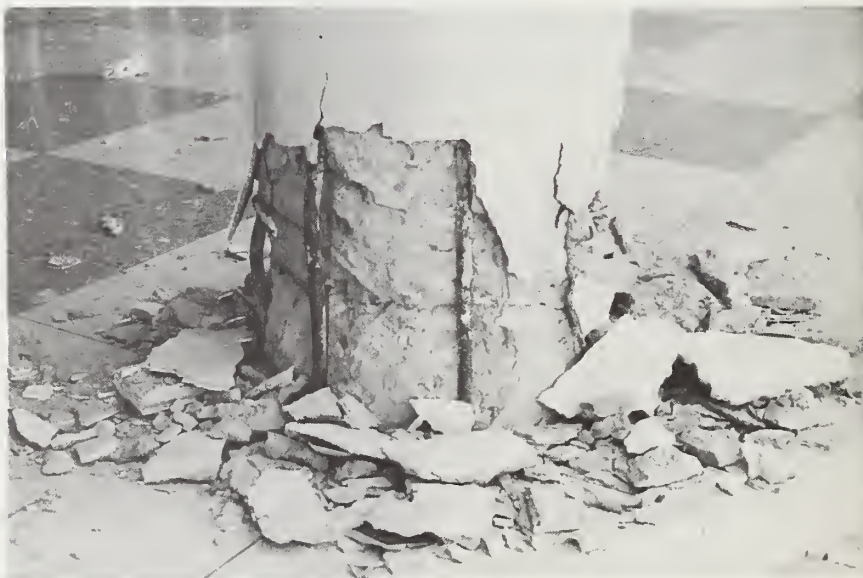
Figure 55-4 Damage at base of canopy columns, undeformed reinforcing, Hospital General El Retiro.

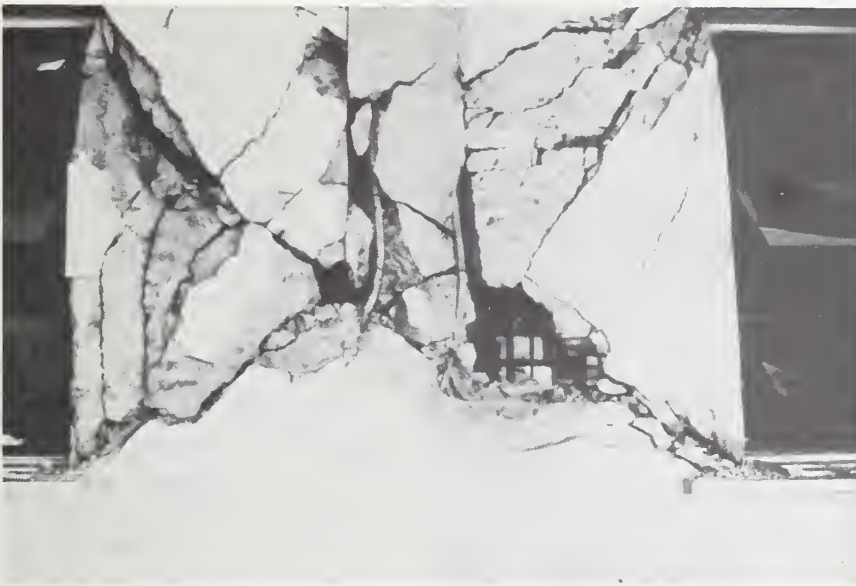
Figure 55-5 Detail of column and wall damage in north facade, undeformed reinforcing, Hospital El Retiro.

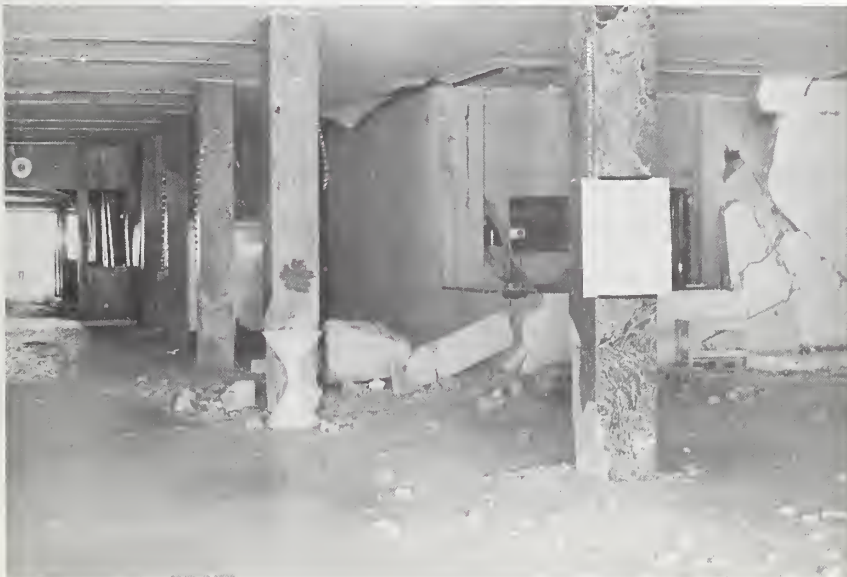
Figure 55-6 Interior view at main entrance, only nonstructural damage apparent, Hospital General El Retiro.

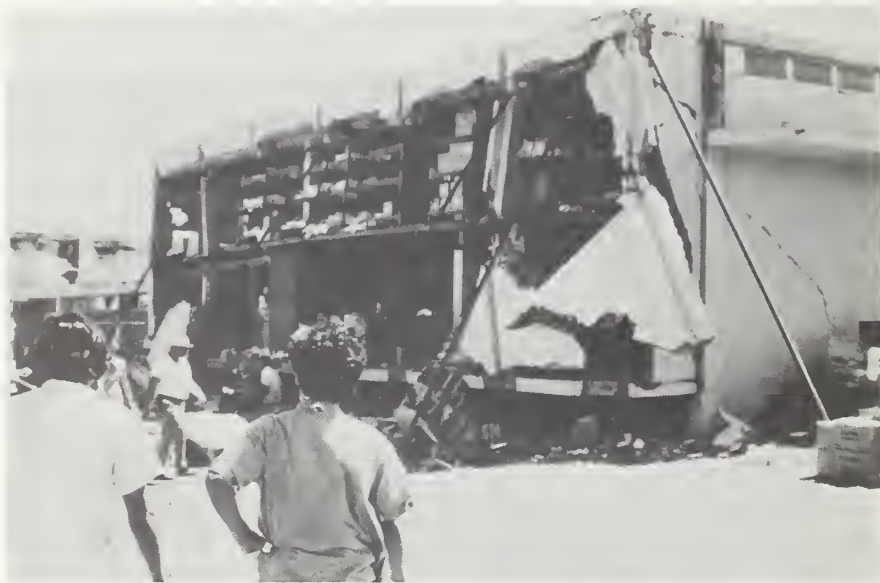
The insubstantial warehouse for medicines was essentially collapsed; the vital supplies conserved by the strength of their shelving, figure 55-8.

Figure 55-8 Medical supply warehouse supported by shelving inside, Hospital General El Retiro.

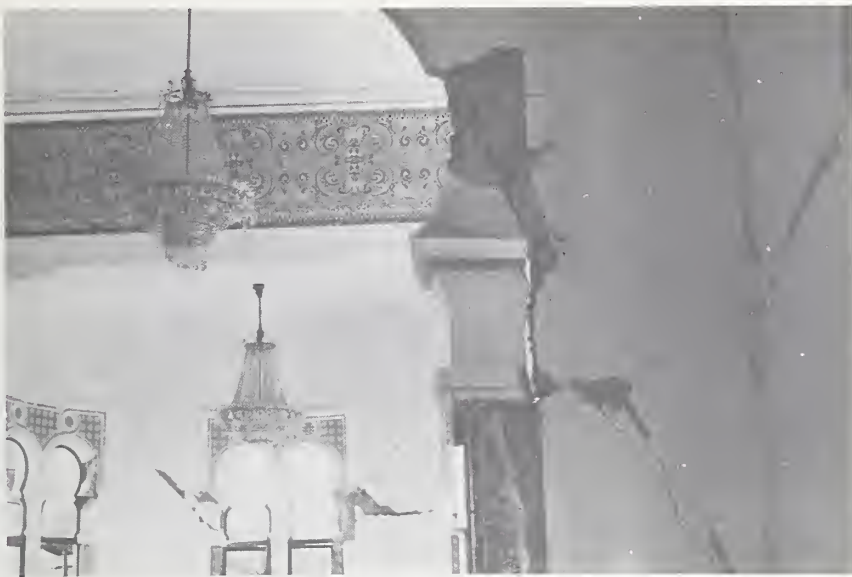
The coverings of terraces at the northeast and northwest of the principal entrance have fallen, figures 57-1 and 60-2. These were steel truss roof elements supported by reinforced concrete columns and beams. The ground floor of the building shows extensive cracking in the reinforced concrete walls and columns with a concentration of cracking at the levels penetrated by doors and windows, figures 60-3 and 60-4. In these areas, the reinforcing was revealed to be undeformed bars. The floor at the back of the main lobby is settled; it was not ascertained whether there was earthfill or damaged structure below this. The western portion of the second floor shows very little damage. In the central portion, the fireplace wall shows extensive cracking and the south central portion of the floor is displaced south toward the crater lake Tiscapa. The roof of the building does not show cracking but major elements of the building are separated.

Figure 60-3 Details of interior damage, Casa Presidencial.

The building requires extensive and expensive repairs. However, it would be essential to assure stability of the foundations of the building prior to any consideration of repairs. At present, the building site appears to be sliding both to the north down the side of the hill and to the south into the crater lake, figures 60-5 and 60-6.

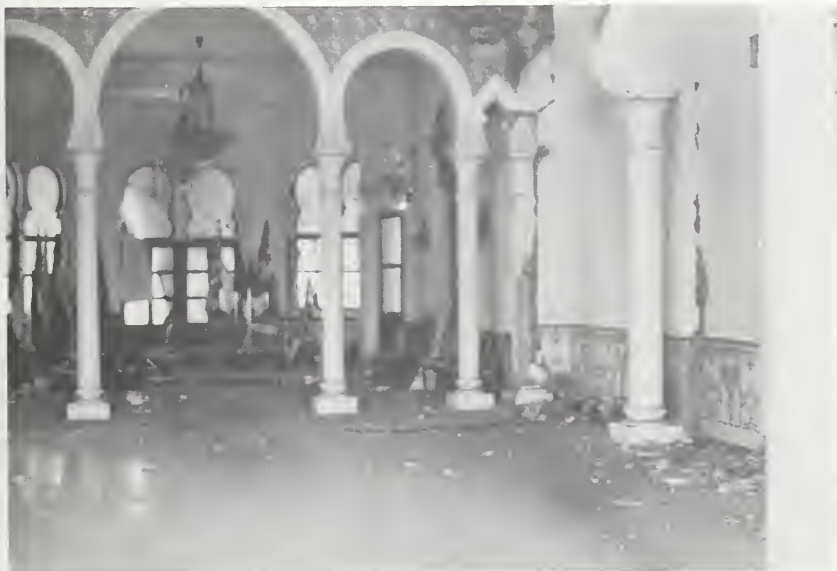
Figure 60-4 Interior damage in main lobby, Casa Presidencial.

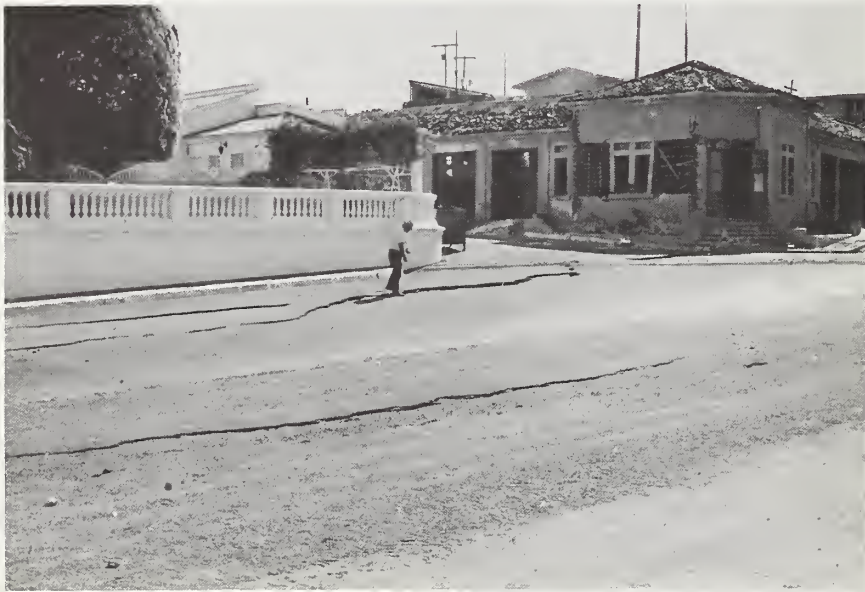
Figure 60-6 Subsidence cracking in road at northwest
of Casa Presidencial.

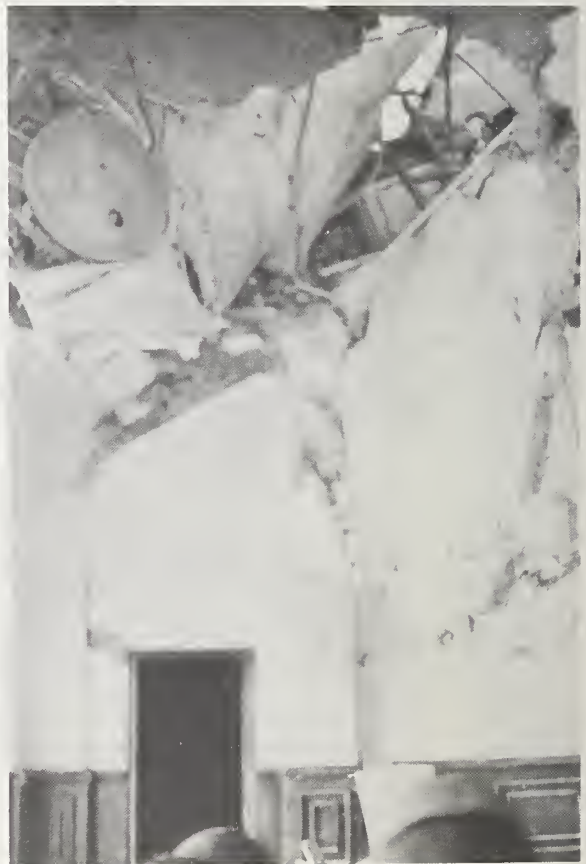
One of the two roof towers has fallen and penetrated the ceiling of the lobby at the entrance of the first floor, figures 61-1 and 61-2. The other tower is sheared and ready to fall. There is extensive wall, beam, and column cracking in the first floor of the building. In the basement of the building there is heavy cracking of the walls, light cracking of some columns, and heaving of the floor or penetration of the wall footings. At the west end of the basement, the east wall is heavily cracked, a west end column is crushed at mid height, figure 61-3, and many columns are lightly cracked.

Figure 61-2 Tower fallen through ceiling of entrance lobby, Residencia Jefe Director.

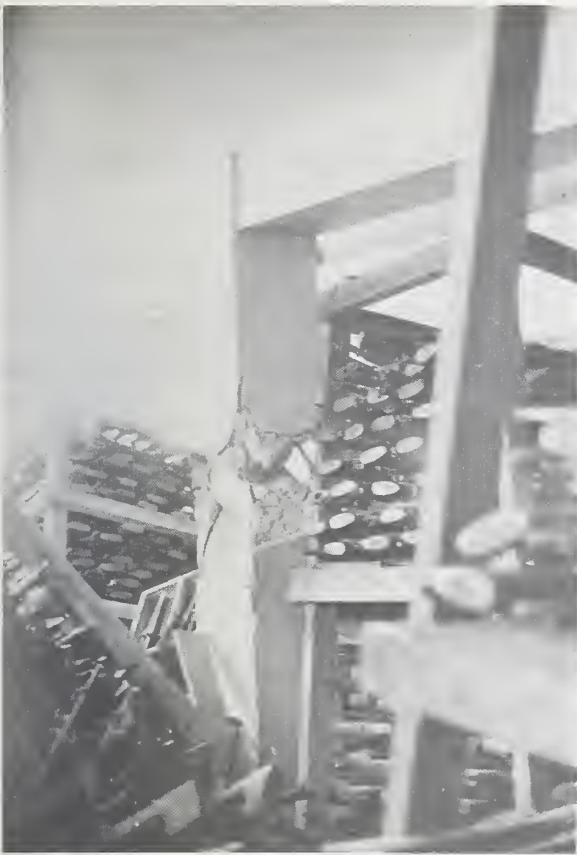
Figure 61-3 Column crushed in basement, Residencia Jefe Director.

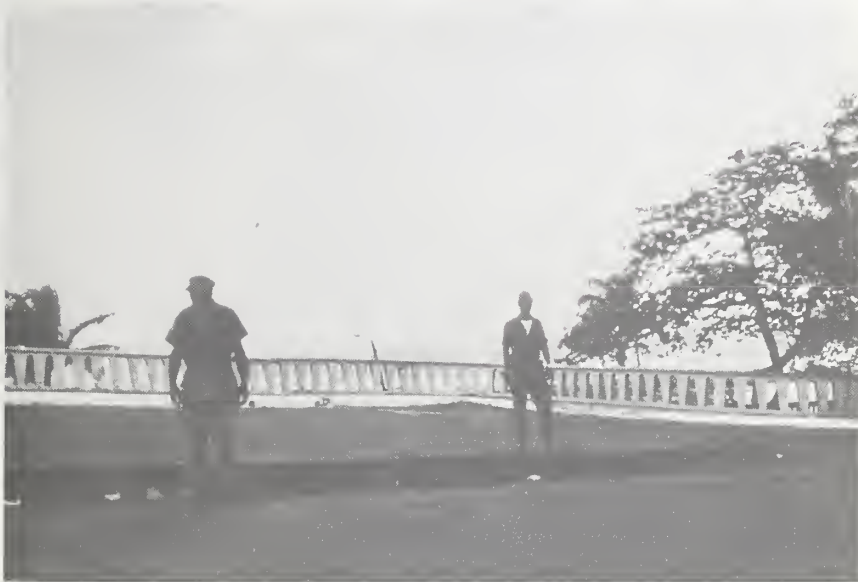
The foundations of the building and the site in general show evidence of instability, figure 61-4. In this area, the movement of the building appears to be down and south into the crater lake. Repair of the building would be an extensive and expensive operation. It should not be undertaken unless stability of the foundations can be assured.

Figure 61-4 Slide movement in front of Residencia Jefe Director.

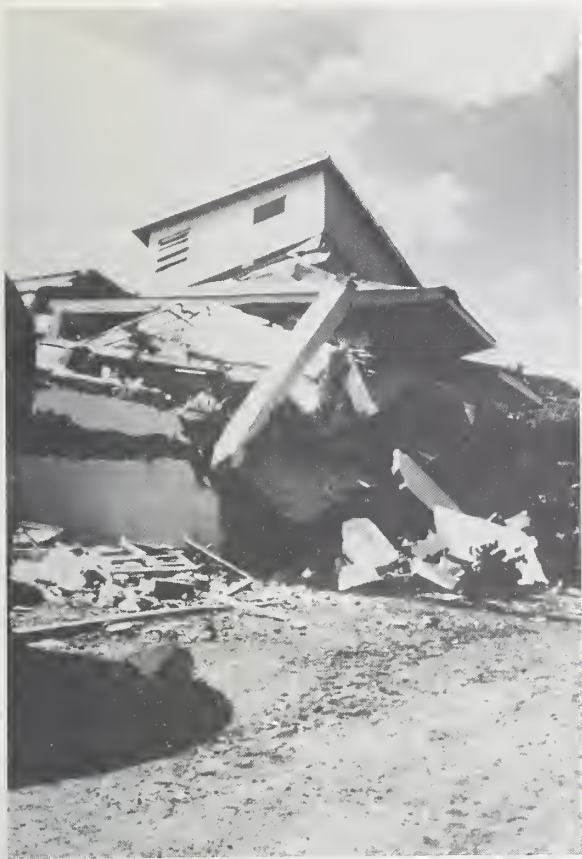
The buildings of the Gerente General, the warehouse immediately west, and the vehicle storage building to the southwest were inspected. The two story building of the Gerente General which had a reinforced concrete frame employing undeformed reinforcing, was completely collapsed, figures 68-1 and 68-2. The warehouse was made up of barrel shells, about 30 ft wide and 200 ft long, supported by reinforced concrete columns at the edge lines on approximately 20 ft spacing. The exterior columns have failed completely at the top of partial height infill walls which increased the column stiffness and thereby the column shear, figures 68-3 and 68-4. Interior columns showed some damages at the top. Repair may be possible, but will require substantial reconstruction and improvement of the roof support system.

Figure 68-1 View of general collapse, Aduana General de Managua.

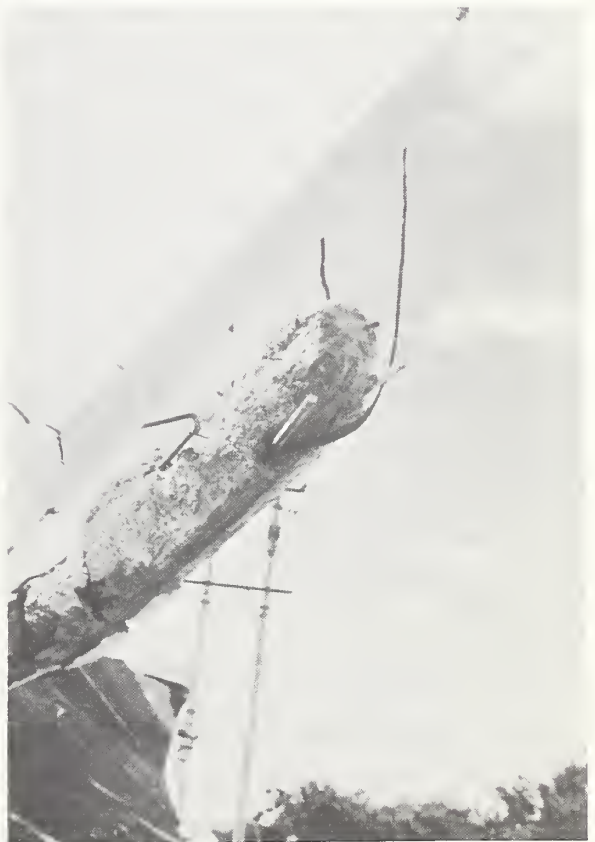
Figure 68-2 Close up of columns showing undeformed, lightly tied reinforcement, Aduana General de Managua.

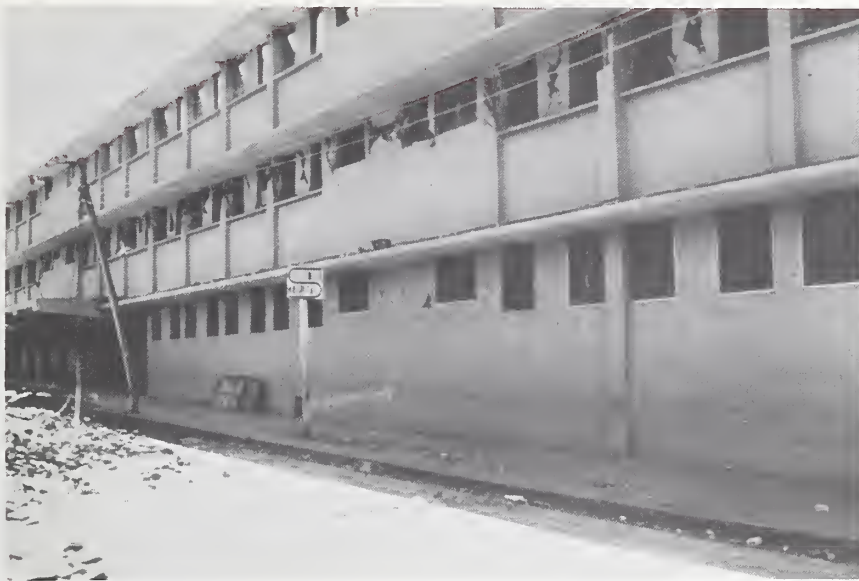
The second floor facades on the north and east sides shows severe column damage above the breast high infilled walls. The columns are approximately 14 by 12 in reinforced with four number eight bars. The corresponding columns on the west facade are much more lightly cracked. There was fire on the third floor of the building which burned the wood frame supporting the corrugated metal roof leading to collapse of portions of the roof. The first floor structure on the east side of the building is in reasonably good condition. Concrete block and heavy brick partitions appear to have braced the frame. Second floor columns on the east side are destroyed as noted above due to the concentration of deformations caused by partial height walls, figure 70-3. The structural system on the third floor of this east side appears to be in good condition in spite of the fire. On the west side of the building, there is major damage to some columns and beams on the second floor. In this region, there is severe cracking and falling of partitions. The first floor shows some shear cracking in stub girders where column spacings change between floors.

Figure 70-1 East facade of the Hospital del INSS, extensive second floor damage, note roof collapse through third floor windows.

The repair of this building is possible but will be very expensive. It may be more economical to build a new hospital when the advantages of a modern building plan are considered. The present building cannot be considered for any use prior to major reconstruction.

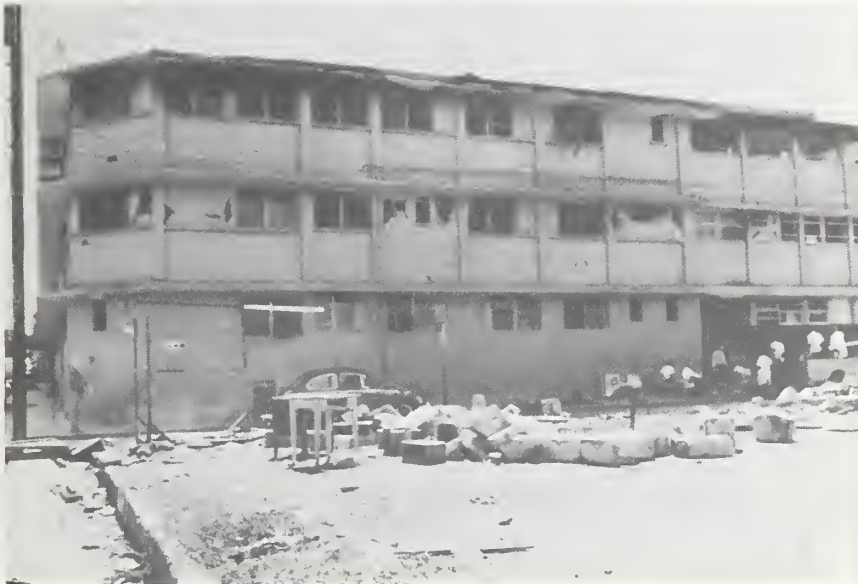
Figure 70-2 North facade Hospital del INSS, much wall and column damage.

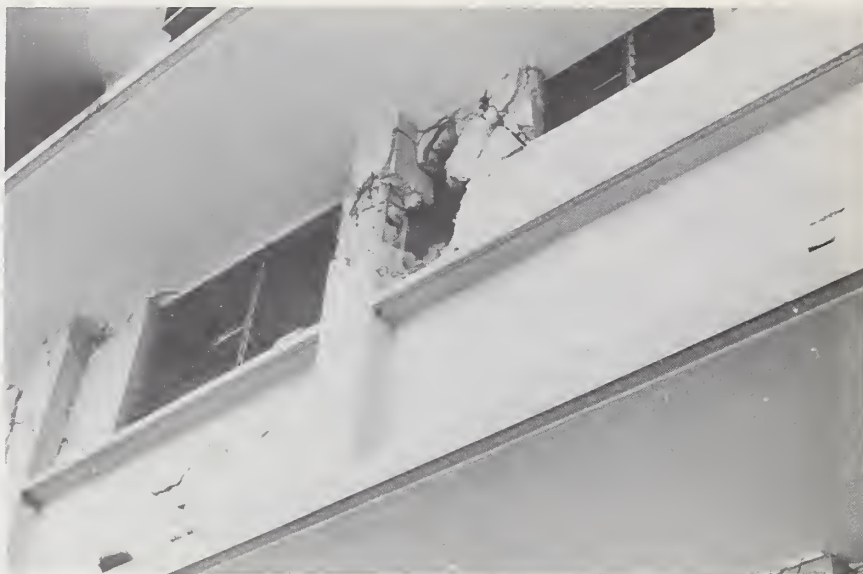
Figure 70-3 Detail of wall and column damage on north facade, Hospital del INSS.

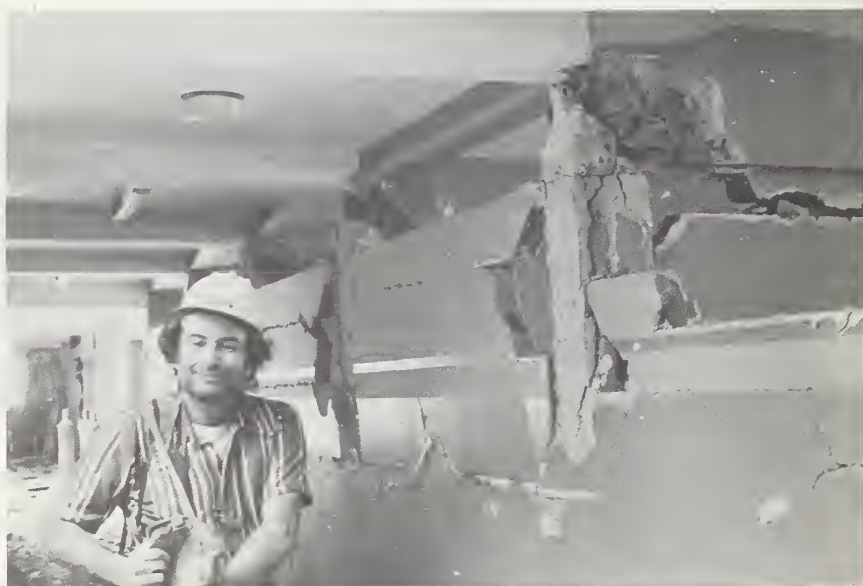
Although the structure did not collapse, extensive damage to unreinforced masonry partitions and infill walls made the building dysfunctional and hazardous to occupants, figures 70-4 and 70-5.

Figure 70-4 Structural and nonstructural damage on east wing, first floor, Hospital del INSS.

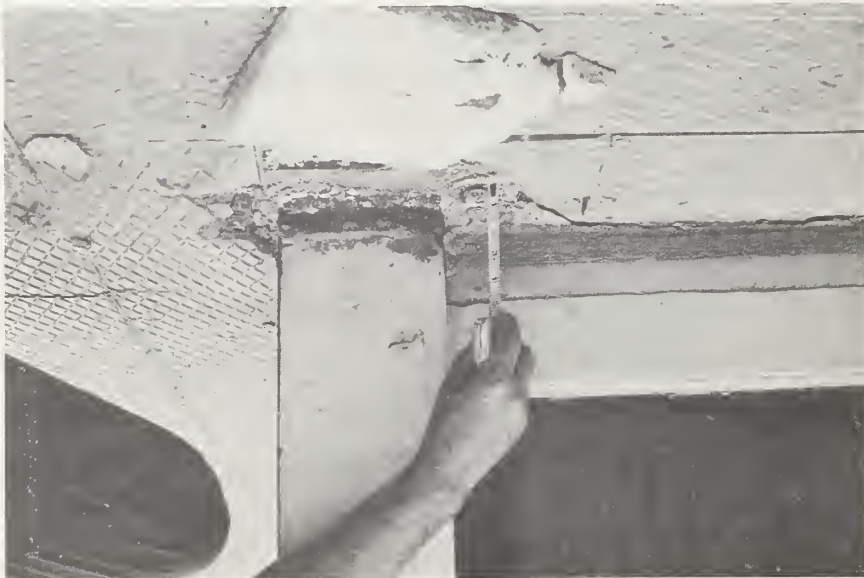
There is evidence of inelastic deformation in the first floor columns. Anchor bolts are lifted as much as 1/4 in along the north side of the building, figure 72-2. Infill concrete block panels at the first floor entrance have cracked; the resulting concentration of deformation has deformed the column at the door frame on the west side, figure 72-3. The weld of the staircase framing to the columns has fractured in this vicinity. At the east side of the south wing of the building, partial height partition walls have led to concentration of deformations in the columns, figure 72-4. This has broken a 6 by 6 in reinforced concrete column reinforced with four number three bars and has deformed the W12X31 steel columns about two in horizontally to the north in the first story at the southeast corner of the building.

Figure 72-2 Lifted anchor bolts along north facade, IBM.

The building appears safe for occupancy. Structural connections should be checked individually to look for weld cracking that is difficult to see in a cursory inspection. A more careful investigation should be conducted to define whether it is necessary or desirable to straighten the deformed columns in the first story.

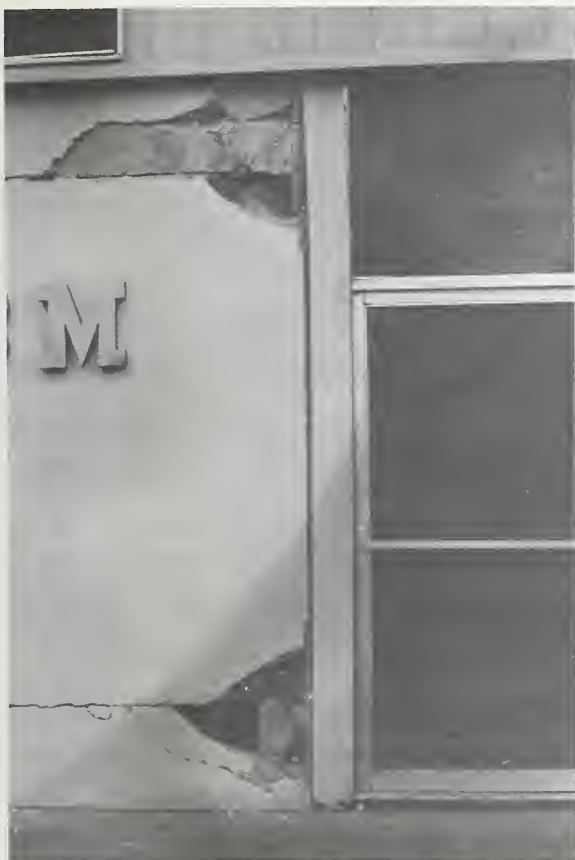
Figure 72-3 Column deformation at IBM building caused by cracked infill panel.

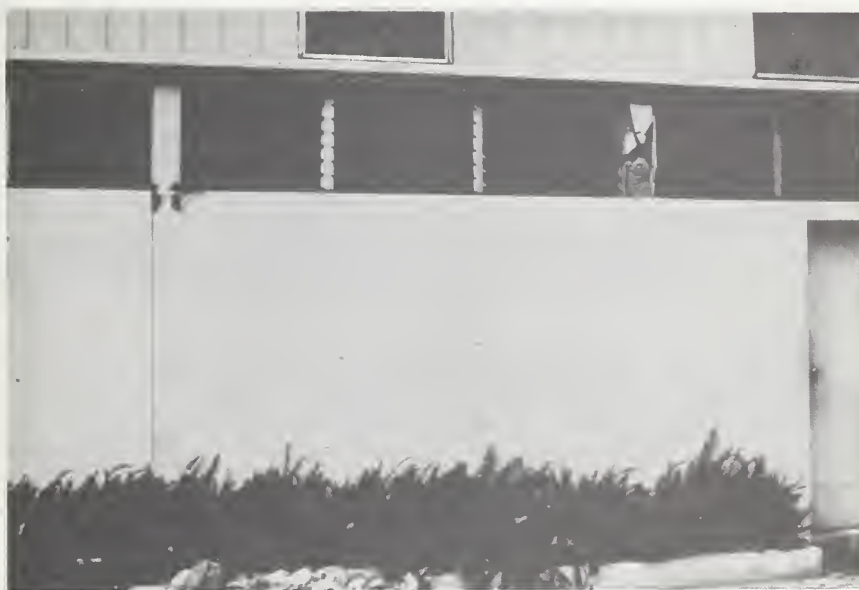
Figure 72-4 Column damage caused by partial height infill wall, IBM building.

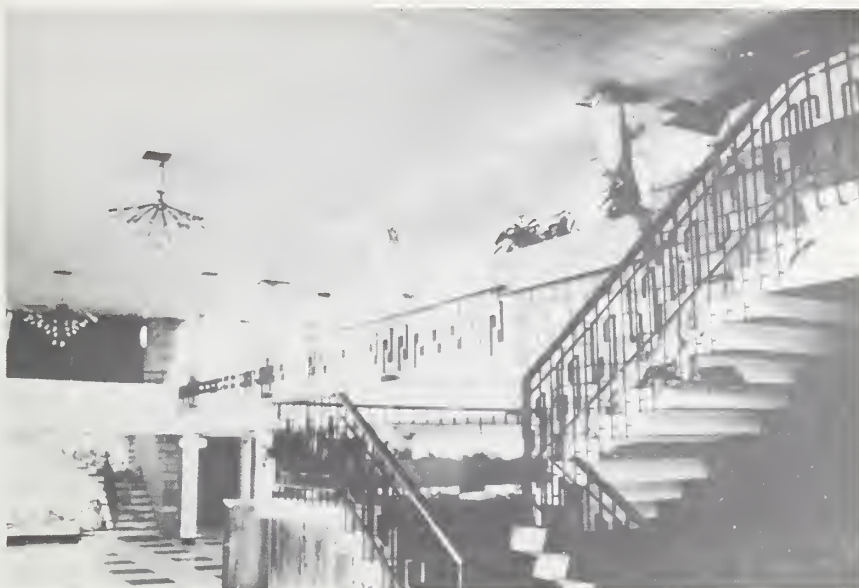
The main wing is severely damaged and partially collapsed, figure 73-1. The eight in thick canopy slab has swayed more than two ft on its steel pipe columns, figure 73-2. An attendant reported that the partial collapse of the reinforced concrete main wing occurred on the first shock of the earthquake. Although it was not closely inspected, the two story wing at the southeast showed no evident damage from the outside. It was pointed out, that new cracking appeared in the entry drive in front of the club at the time of the earthquake. This may be part of the fault breaking in the earthquake since there are no strong slopes in the vicinity suggesting sliding action.

Figure 73-1 Severe structural damage in main building of the Country Club Tejapa.

The main wing of the club appears to require complete reconstruction.

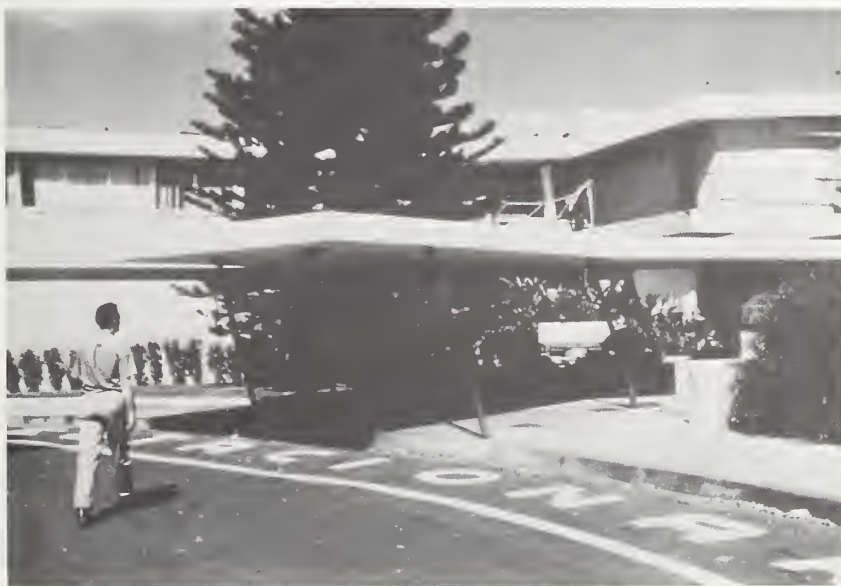
Figure 73-2 Sway deformation of heavy canopy slab, Country Club Tejapa.
